KOOTENAY-COLUMBIA

DISCOVERY CENTRE SOCIETY

SITE SELECTION & SCHEMATIC DESIGN

JULY 2018

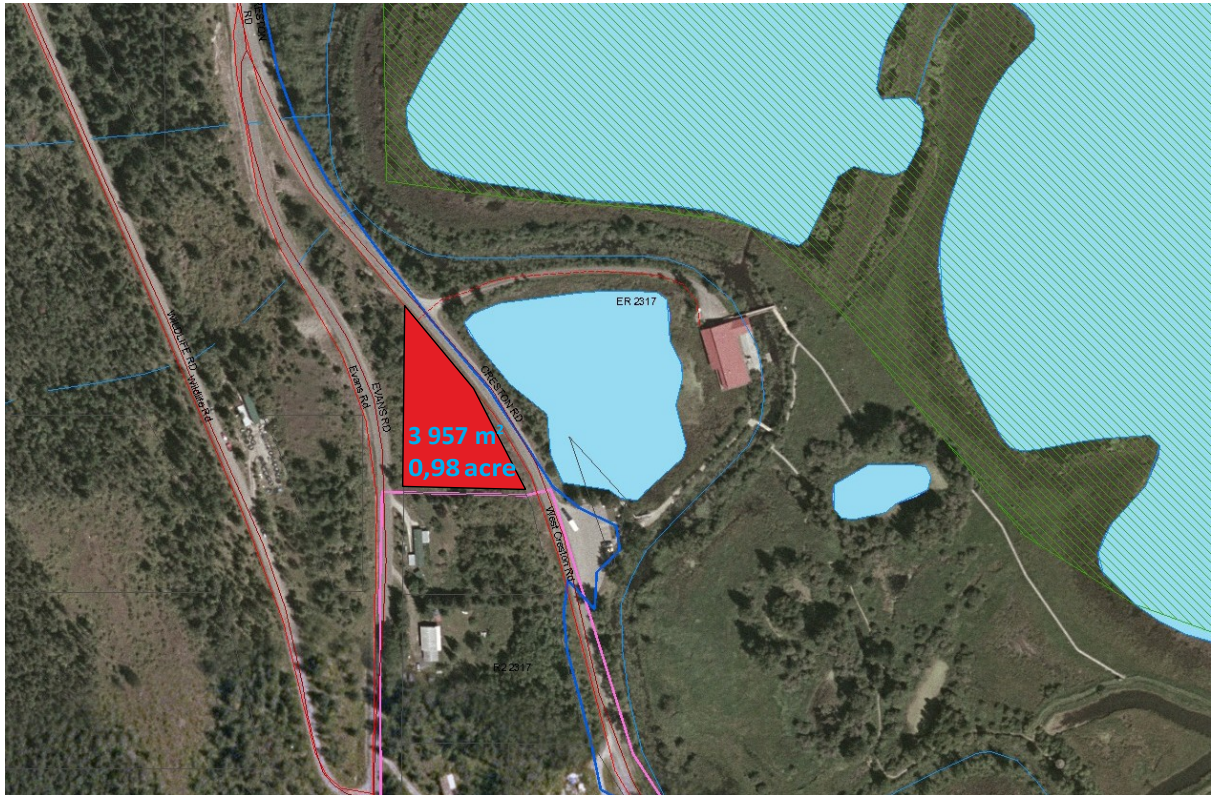
This site is in very close proximity to the entry point to the wetlands, separated by West Creston Road. The site had a number of constraints and opportunities that were observed in review of the site:

- Excellent dramatic views of the wetlands and valley
- Good proximity to wetlands and West Creston Road, but limited access because visitors would be required to cross West Creston Road. This presented a major challenge, as traffic along the road can be fast and numerous at periods during the day. Additionally, the distance to the access points in the wetland is relatively far, and would be excessive for small children and people with mobility challenges.

- Currently no septic or water is available on site
- The property is Federal Crown Land
- Electrical service available at roadway for new connections
- The site is almost entirely comprised of a rocky outcrop, so any construction of a building or parking lot would require extensive blasting and fill. This was identified as a major drawback of the site, as the costs for this work would be excessive

- Site may be too restrictive for the new centre. Between the pie-shaped parcel, and significant changes in grade from one side of the property to the other, the buildable area would be restrictive.

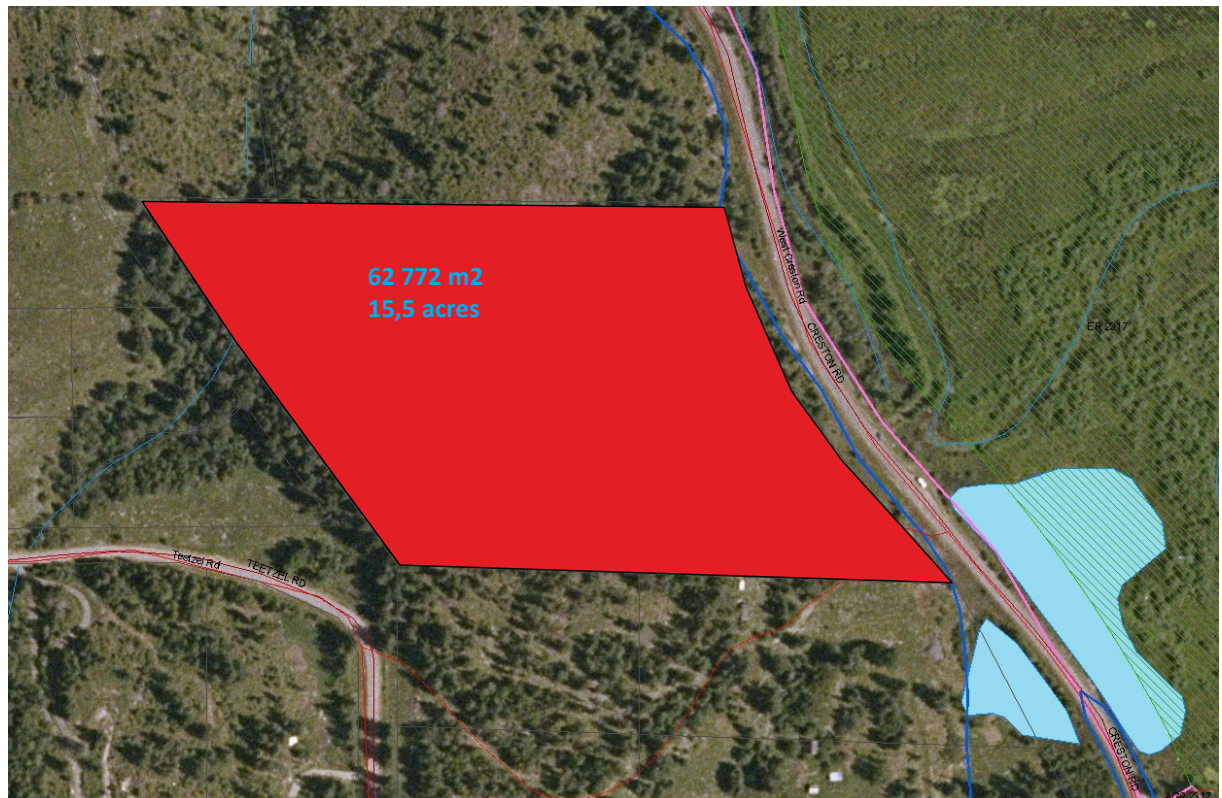
- The site is located next to the wetlands, but in an area that is not close to the boardwalks and existing public access to the wetlands. The adjacent wetlands are also not very deep, and seasonally can dry up and be inaccessible by canoe. A shuttle bus system to the current entry point to the canals from this location is an option to address this, but was not preferred.

- Excellent dramatic views of the wetlands and valley
- Currently no septic or water available
- The property is Federal Crown Land
- Electrical service available at roadway

- On rock which would involve blasting for foundations, roadwork, and parking lot
- The site is almost entirely comprised of a rocky outcrop, so any construction of a building or parking lot would require extensive blasting and fill. The steep slope on the property would suggest that a road requiring extensive work would be necessary to access the relatively flat building sites at the upper portion of the property. This was identified as a major drawback of the site, as the costs for this work would be excessive.

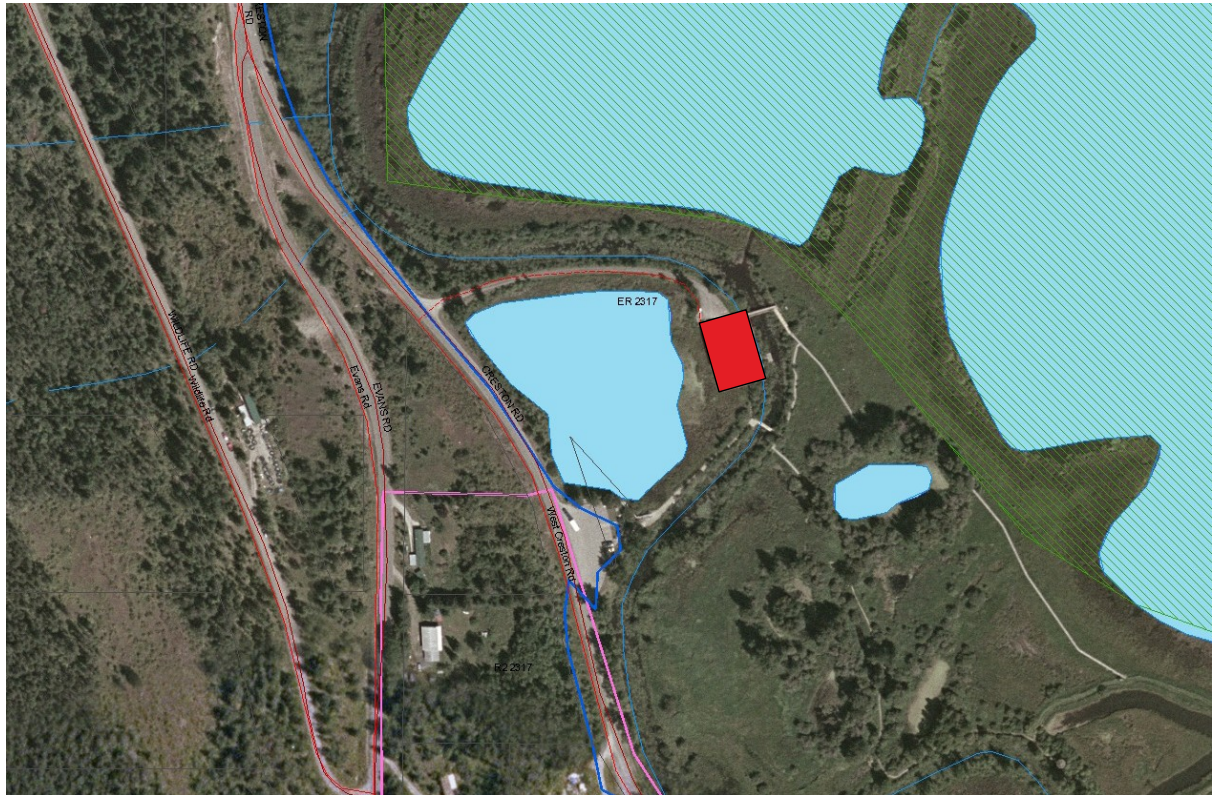
The existing site has proven to be a landmark site with a prominent presence in the landscape, and visible from the highway as people pass by.

- Excellent dramatic views of the wetlands and valley
- Easy access - parking on site is limited, but the network of boardwalks and access to the wetlands is in place
- Existing Electrical, Water, and Septic are in place, although may require upgrading.
- The existing building and creosote pile foundation are understood to be removed regardless of which site is chosen. New foundations for the replacement building may present challenges if a traditional concrete foundation, but could be supported using a driven steel piling or screw pile foundation at a more reasonable cost.
- Access to the building site is established; a boardwalk extends from the existing limited parking area, and an access driveway extends from West Creston Road.

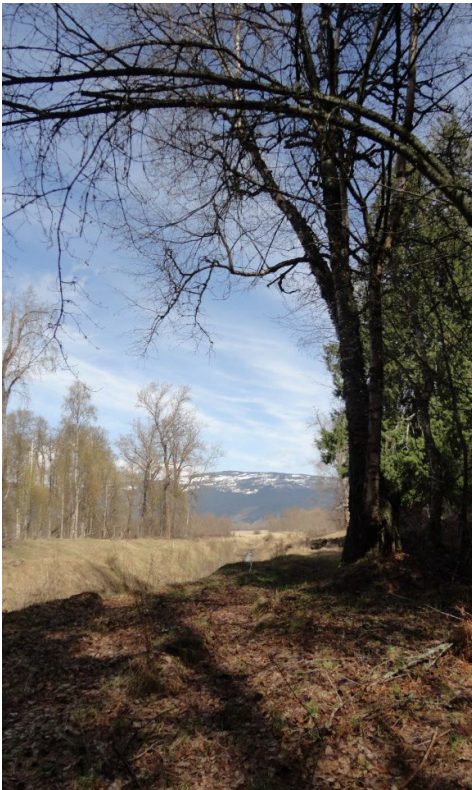
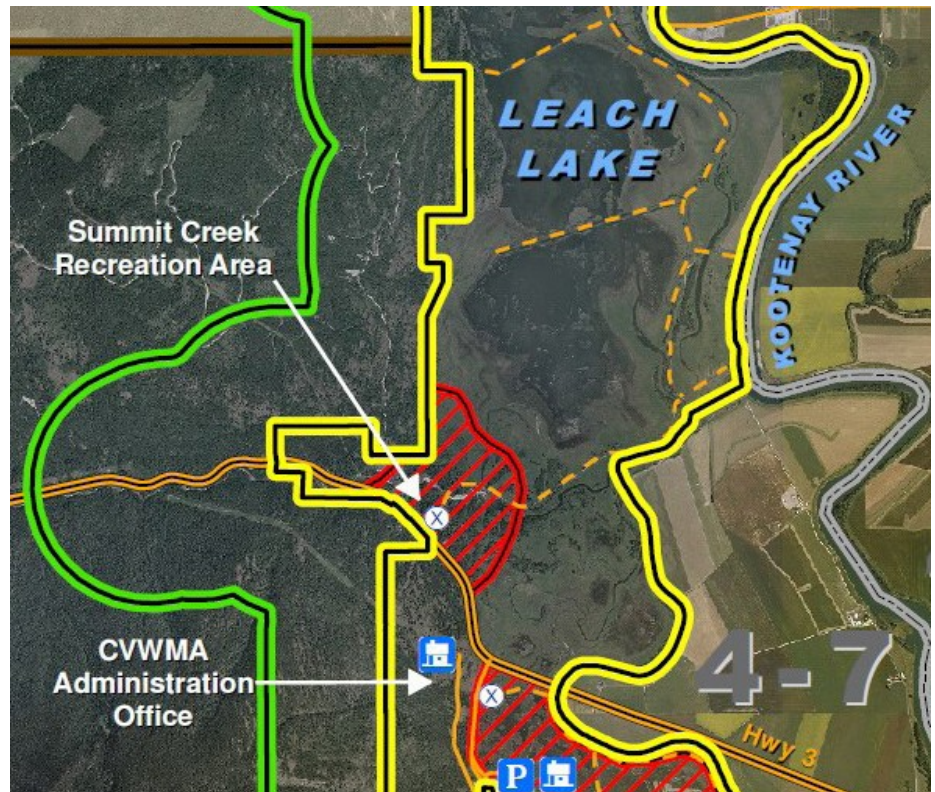
SUMMIT CREEK RECREATION AREA

- Potential Building Site does not have direct access to the wetlands or views across the valley
- The KCDCS wetlands are not close, and would have to be accessed by shuttle to the existing boardwalk and canoe access - or develop a new access point in closer proximity. This was indicated as an option that was not favoured.

- Existing services from a previous building are in place, updates may be required
- The site would be easy to build on, as there was a building in place previously.

- Easy access and existing parking areas with some pavement levelling and rehabilitation required
- Great site but not ideal for this project as it is too removed from the KCDCS and has poor connection to the wetlands

- Mature Cottonwood trees are also a major hazard, and there is a potential for flooding of the building site from Summit Creek - even with flood prevention dykes, this site has a lot of liability from potential flooding, as a simple log jam could cause substantial flooding of a new building

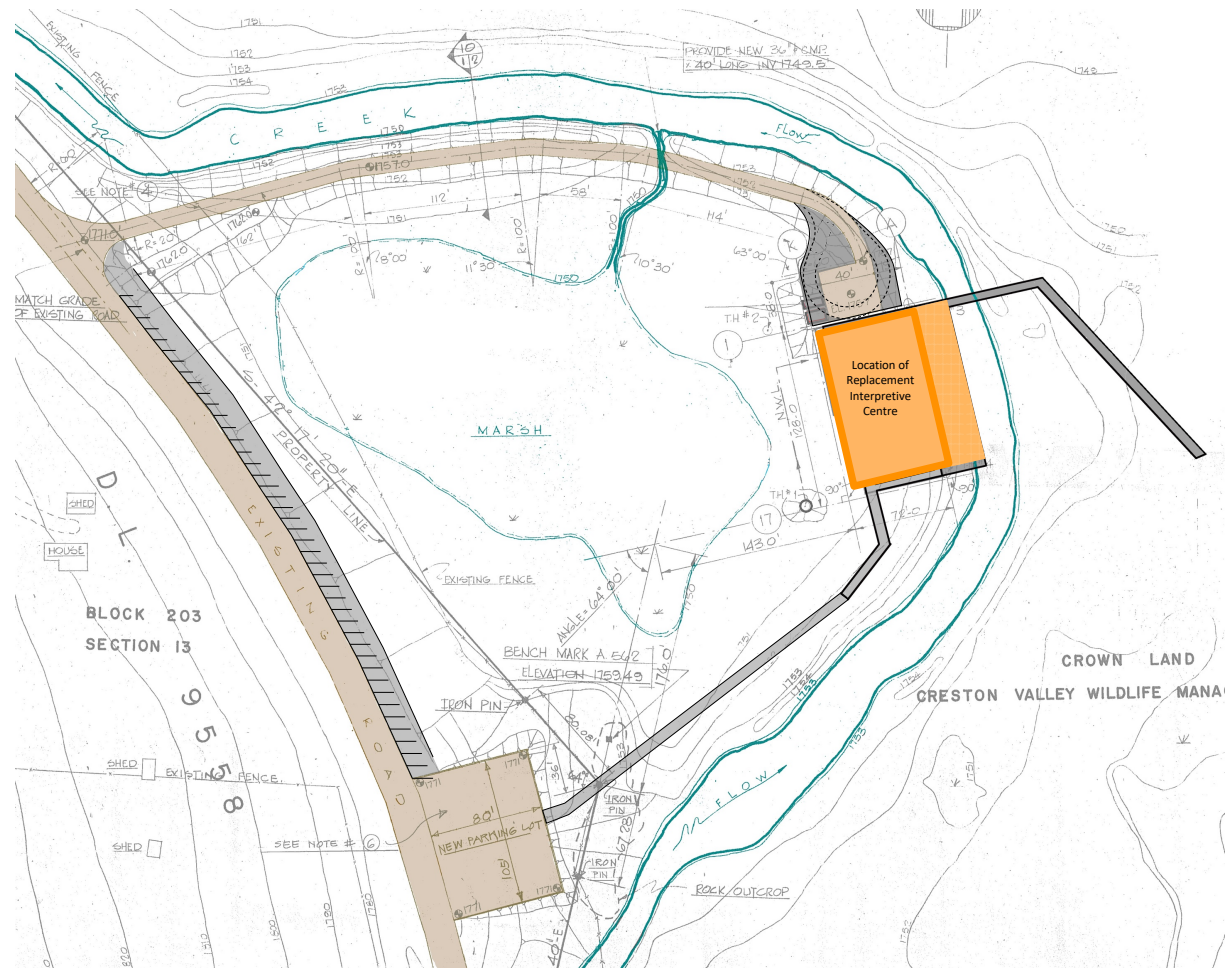
PROPOSED SITE PLAN

- A dropoff area and new turnaround has been incorporated into the existing access driveway to the rear entrance of the existing building. This will allow for an accessible dropoff point for people with limited mobility, as well as small touring buses - the area does not allow for a large turning area, so not all sizes of vehicles have been accommodated. Similarly, large fire department vehicles will not be able to turn around, and it is assumed that trucks would have to back out or run hoses from the street in an emergency (as is currently the case).

- As part of the review of the Schematic Design Options, a review of the site configuration was undertaken. Parking on site has historically been very limited, and available areas for expansion are also very limited. During peak events, overflow parking typically extends along the length of West Creston Road, which creates a somewhat hazardous situation for pedestrians walking to and from their vehicles.

- Because of the lack of available land, several options for filling in portions of the adjacent wetland were explored. This was discussed at length with the staff biologists in the context of wetland conservation efforts, as filling in wetland areas is typically contrary to sensitive wetland conservation. In the past, water levels fluctuated substantially, limiting the intensity of growth of vegetation on the banks of the river and shores of the wetlands and in turn providing good nesting habitat for the painted turtle. With the construction of the dams along the Kootenay and Columbia River, the vegetation has grown substantially, and nesting habitat has become more scarce. Along the length of the highway beside the KCDCS Interpretive Centre is an area that would benefit from a habitat restoration to support additional shoreline nesting areas, and could be incorporated into the expanded fill that would be used to provide additional parking spots along West Creston Road as shown in the proposed site plan. Use of this area adjacent to the highway would have to be negotiated, as it is not within the current land parcel where the existing centre resides.

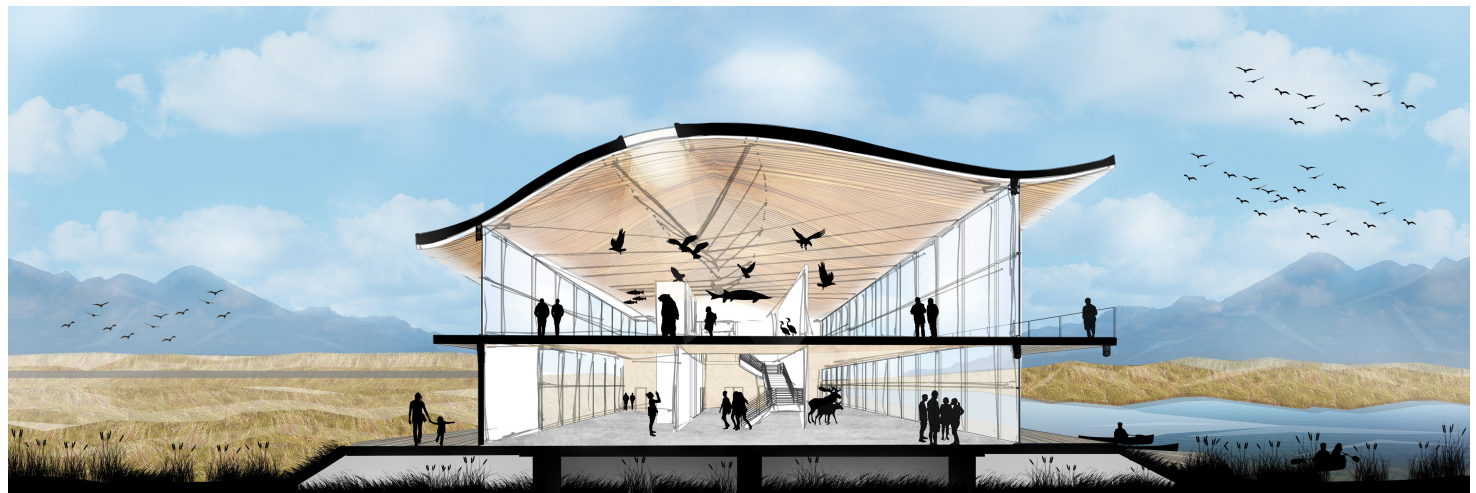
SECTION THROUGH THE BUILDING

- Of option 1 and 2, it was preferred to provide vaulted ceiling spaces with second storeys to allow for expansive views of the valley.
- Option 1 and 2 were based on similar areas and similarly complex construction types - Estimates of Total Probable Costs for both options are represented as identical for this early stage.

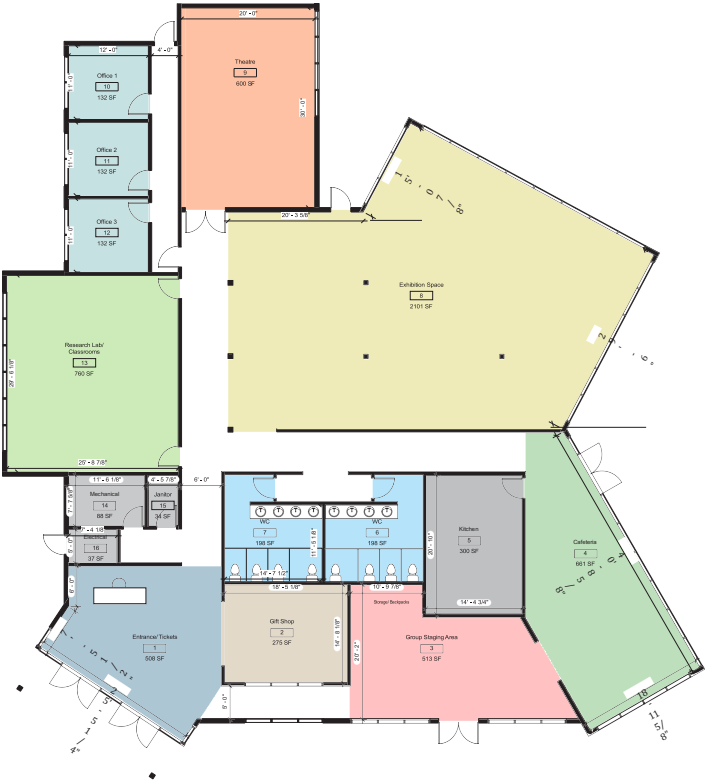
FLOOR PLAN - LEVEL 1

- A third option was also provided as a more cost-conservative concept, which provided for a reduction in program areas to allow for the elimination of vertical circulation spaces (stairs, elevators, HVAC shafts, etc.).
